**WINE COOLER**

Model:PWC285MB/PWC286MLS

This product is for domestic use only  
Use & care manual  
Important safeguards

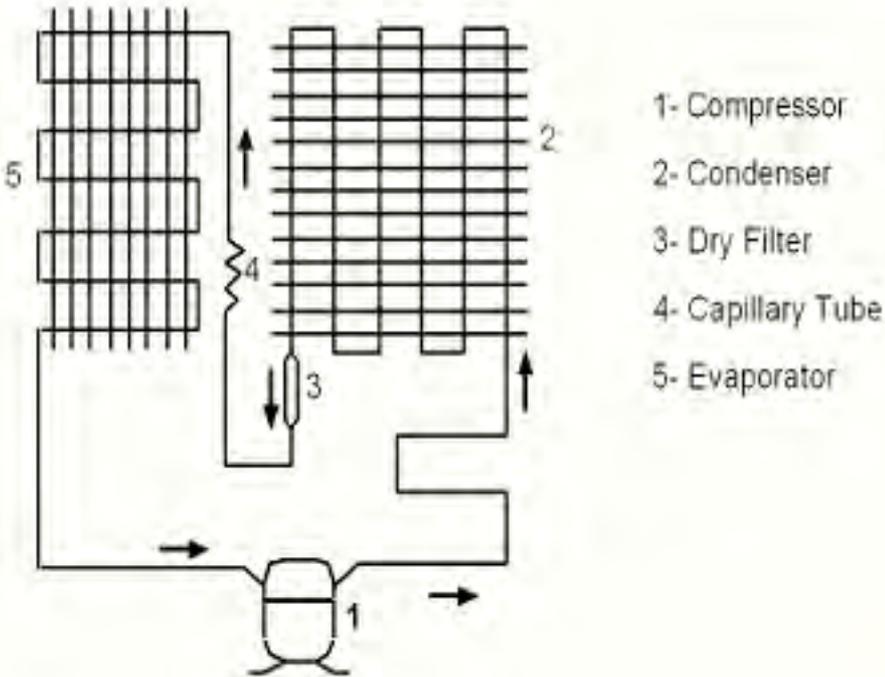
### 1 Schematic diagram of System Flow Chart

### 2 Brief Description of System Flow Chart

Model PWC285MB/PWC286MLS is a direct cooling single-system wine cooler. When the wine cooler is just powered on, the refrigerant flows in the sequence: 1->2->3->4->5>1

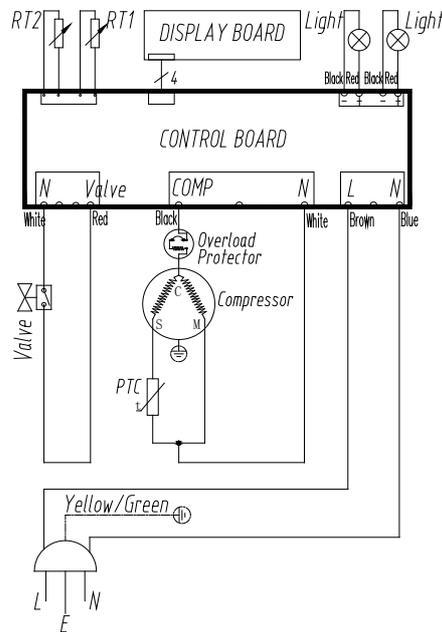
### 1 Schematic Circuit Diagram

### Brief Description of Control Principle

Model PWC285MB/PWC286MLS is a direct cooling single-system wine cooler

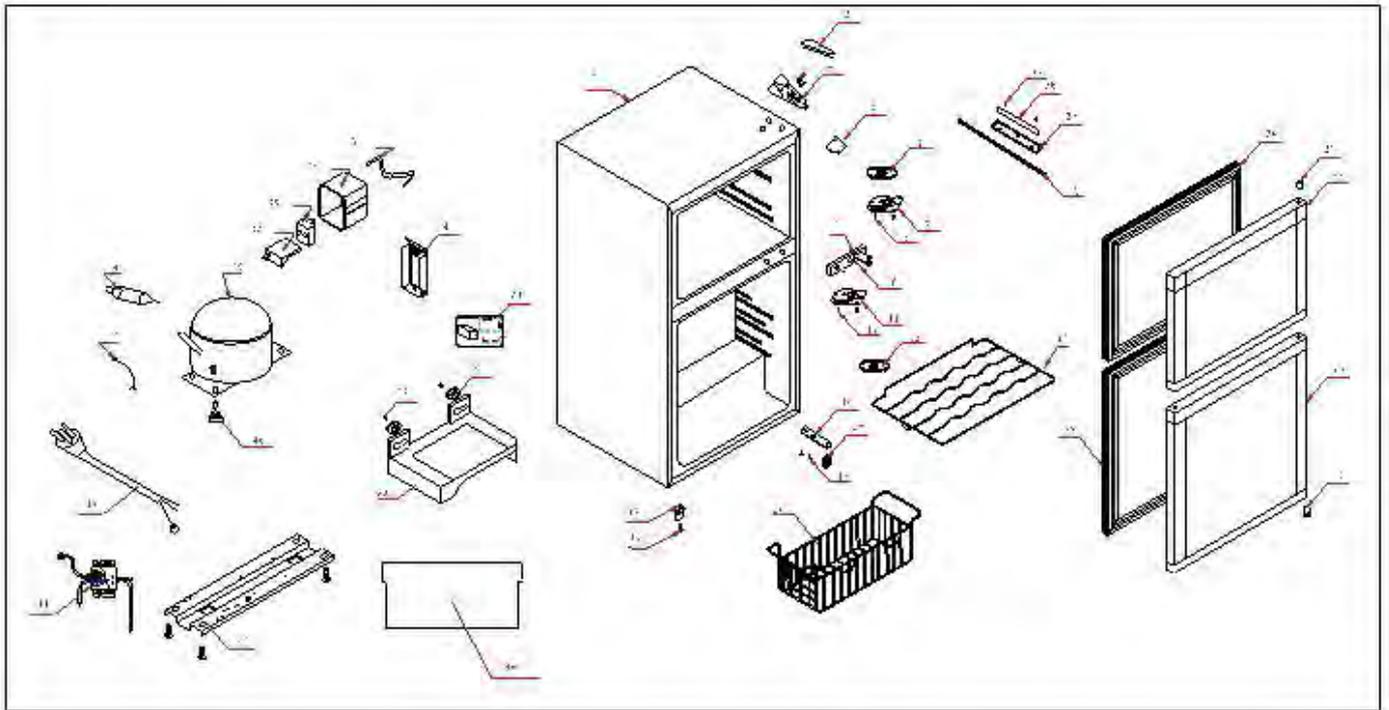
代号	图号	物料编码	零件名称		数量	备注 remark
1	NE27-200	-503705060081	箱体总成	cabinet foamed	1	
2	NE26-102	501107960001	上铰链罩	hinge gemel guard up	1	
3		502500100018	机用螺钉	tapping screw	3	M5*12
4	NE26-101	502905060029	上铰链组件	hinge assy,top	1	
5	NE26-207	500707960001	上铰链螺钉板	hinge assy,top bolt ban	1	
6	643205	501133060010	感温盒盖	cover,thermostat senson	2	
7	B173.0-5	502410000067	LED 照明灯组件	Led lamp	1	
8		502500100005	十字槽盘头不锈钢自攻螺钉	tapping screw	3	ST4*12
9	NE07-104	502905060024	中铰链	hinge assy,center	1	
10		502500100018	机用螺钉	tapping screw	2	M5*12
11	B173.0-5	502410000067	LED 照明灯组件	Led lamp	1	
12		502500100005	十字槽盘头不锈钢自攻螺钉	tapping screw	3	ST4*12
13	643205	501133060010	感温盒盖	cover,thermostat senson	1	
14	B130.0.2	502905060031	下铰链	hinge assy,bottom	1	
15		502500100018	机用螺钉	tapping screw	2	M5*12

16	N002-118	501106840006	调节脚	tune up leg	1	
17		502500100005	十字槽盘头不锈钢自攻螺钉	tapping screw	1	ST4*12
18	B102.5.1-1	501105040022	固定脚	fixing leg	1	
19	B130.0-1	502901060029	镀铬弯棚架	curve shelf,chromeplate	5	
20	NE27-106	502903050013	挂篮	Rack	1	
21			过线轴套			
22	NE26-305	-503700160083	上室玻璃门总成	glass door assy,top	1	
23	NE26-306	-503700160084	下室玻璃门总成	glass door assy,bottom	1	
24	NE27-302	501107960002	上室门封条	door seal,top	1	
25	NE27-312	501107960003	下室门封条	door seal,bottom	1	
26	NE09-307	501108260045	门封卡槽		1	
27	NE28-304	501108960004	显控板安装盖		1	
28	NE26-501	502301060071	显控板	Display Board	1	
29		502500100005	十字槽盘头不锈钢自攻螺钉	Self Tapping Screw	3	ST4*12
30	B116.5	501106840008	蒸发盘	ablate tray	1	
31	B116A.1-9	501113310009	蒸发盘挂钮	ablate tray pothook	2	
32		502500100005	十字槽盘头不锈钢自攻螺钉	Self Tapping Screw		ST4*12
33	NE26-211	501107960007	主控板安装座	control board cover	1	
34	NE26-105	501107960008	主控板安装盒			
35		501499900332	过载保护器	Overload Protecior	1
